Technical Report – R4790916075 CWCT – Standard for systemised building envelopes – 2005

Fairview Europe Ltd t/a Valcan

VitraDual Planking System

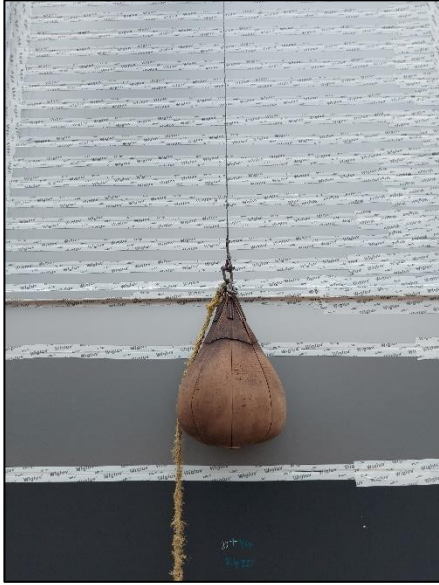
Red Zone				
Impact Reference	Test Classification	Impact Energy (J)	Observations	Result
A1	Cat B	120 x 3 500 x 1	No Damage No Damage	Class 1 Negligible Risk
B1	Cat B	120 x 3 500 x 1	No Damage No Damage	Class 1 Negligible Risk
C1	Cat B	120 x 3 500 x 1	No Damage No Damage	Class 1 Negligible Risk
D1	Cat B	120 x 3 500 x 1	No Damage No Damage	Class 1 Negligible Risk
E1	Cat B	120 x 3 500 x 1	No Damage No Damage	Class 1 Negligible Risk

Photograph No. 2 - During the test, no damage was observed

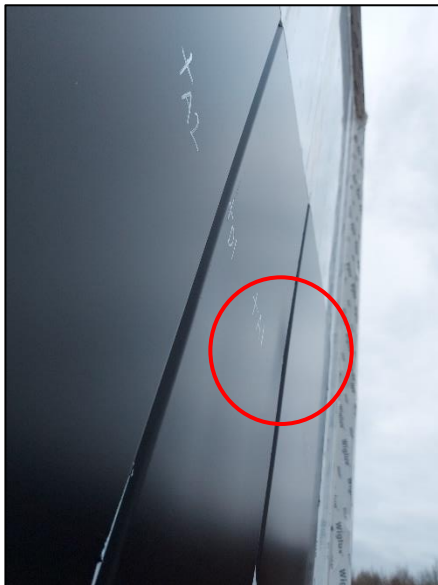
Blue Zone				
Impact Reference	Test Classification	Impact Energy (J)	Observations	Result
A1	Cat B	120 x 3 500 x 1	No Damage Slight Dent	Class 1 Negligible Risk
B1	Cat B	120 x 3 500 x 1	No Damage No Damage	Class 1 Negligible Risk
C1	Cat B	120 x 3 500 x 1	No Damage Slightly concaved panel	Class 1 Negligible Risk
D1	Cat B	120 x 3 500 x 1	No Damage No Damage	Class 1 Negligible Risk
E1	Cat B	120 x 3 500 x 1	No Damage No Damage	Class 1 Negligible Risk
F1	Cat B	120 x 3 500 x 1	No Damage No Damage	Class 1 Negligible Risk

Photograph No. 3 – Damage caused following impact ref A1

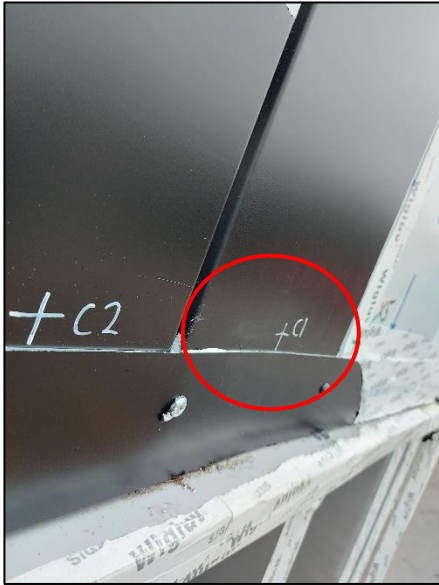
Photograph No. 4 – Damage caused following impact ref C1

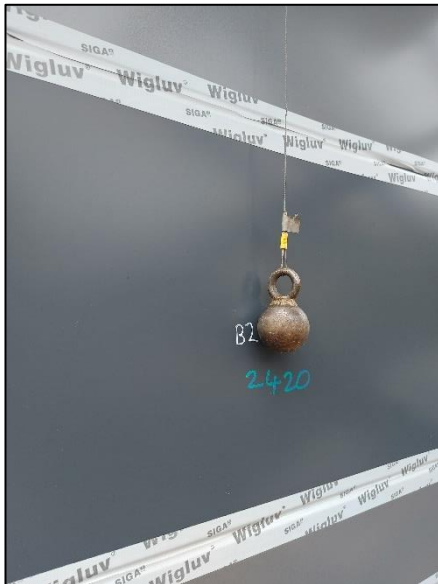
Red Zone				
Impact Reference	Test Classification	Impact Energy (J)	Observations	Result
A2	Cat B	10 x 1	No Damage	Class 1 Negligible Risk
B2	Cat B	10 x 1	No Damage	Class 1 Negligible Risk
C2	Cat B	10 x 1	No Damage	Class 1 Negligible Risk
D2	Cat B	10 x 1	No Damage	Class 1 Negligible Risk
E2	Cat B	10 x 1	No Damage	Class 1 Negligible Risk

Photograph No. 5 - During the test, no damage was observed

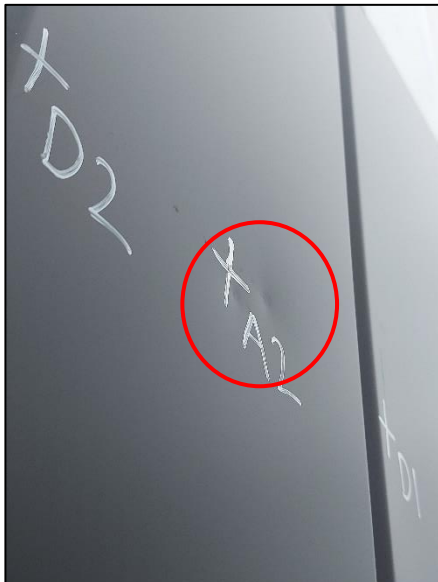
Blue Zone				
Impact Reference	Test Classification	Impact Energy (J)	Observations	Result
A2	Cat B	10 x 1	Dent	Class 2 Negligible Risk
B2	Cat B	10 x 1	No Damage	Class 1 Negligible Risk
C2	Cat B	10 x 1	Dent	Class 2 Negligible Risk
D2	Cat B	10 x 1	No Damage	Class 1 Negligible Risk
E2	Cat B	10 x 1	No Damage	Class 1 Negligible Risk
F1	Cat B	10 x 1	Dent	Class 2 Negligible Risk

Photograph No. 6 – Damage caused following impact ref A2

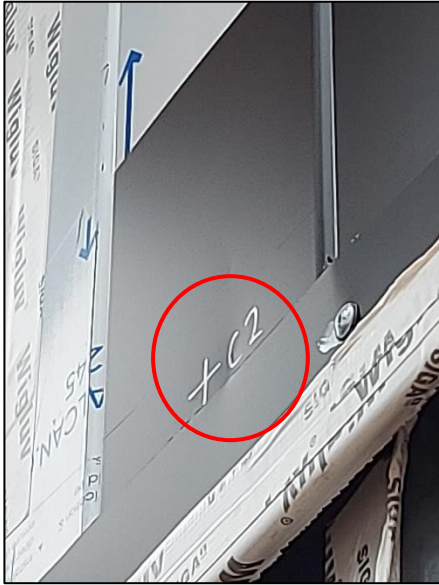
Photograph No. 7 – Damage caused following impact ref C2

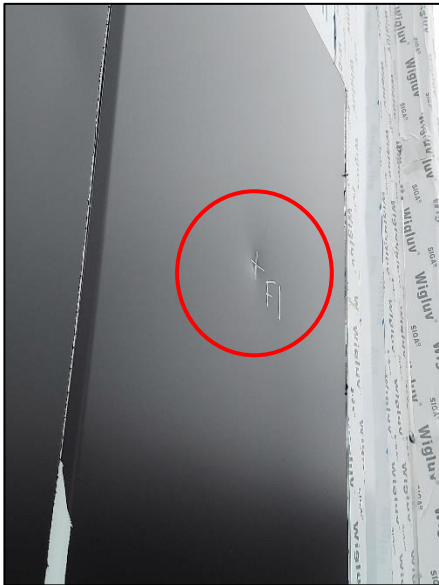
Photograph No. 8 – Damaged caused following impact ref F1

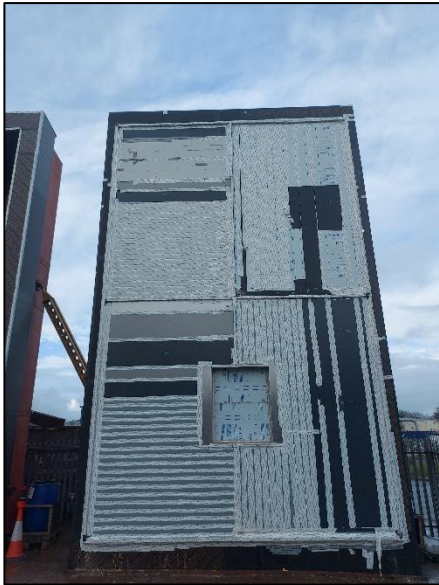
Photograph No. 9 - Sample prior to dismantle

There was no water evident in the system in parts designed not to be wetted, and it was found that the system fully complied with the system drawings in Section 7 provided by Fairview Europe Ltd t/a Valcan at the time of the dismantle.
